MEADOW RUN DAM

NDI ID NO. PA-00555

PHASE I INSPECTION REPORT
NATIONAL DAM INSPECTION PROGRAM

JUNE 1980

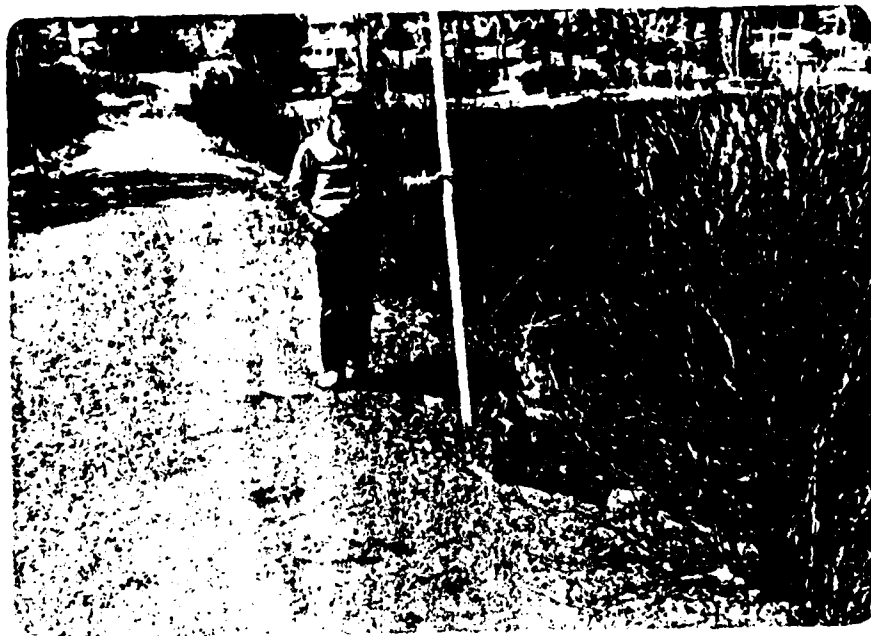
b. Embankment. The upstream slope of the embankment is covered by sparsely-growing, high brush (Photograph A, B and C). There are some eroded areas on the upstream slope. They are typically 10 to 15 feet long (Photograph C). Parts of the upstream slope above normal pool elevation are near-vertical. The top of the dam is curved in plan, with the part to the left of the outlet works deflecting downstream. Near the point of deflection, which is the highest section of the embankment, there are narrow cracks on the top of the dam that are parallel to the axis of the dam. One 8-foot long crack near the upstream edge of the top and two 3-foot long cracks near the downstream edge were observed. The cracks are hairline in width and their depth could not be probed.

C. Upstream Slope

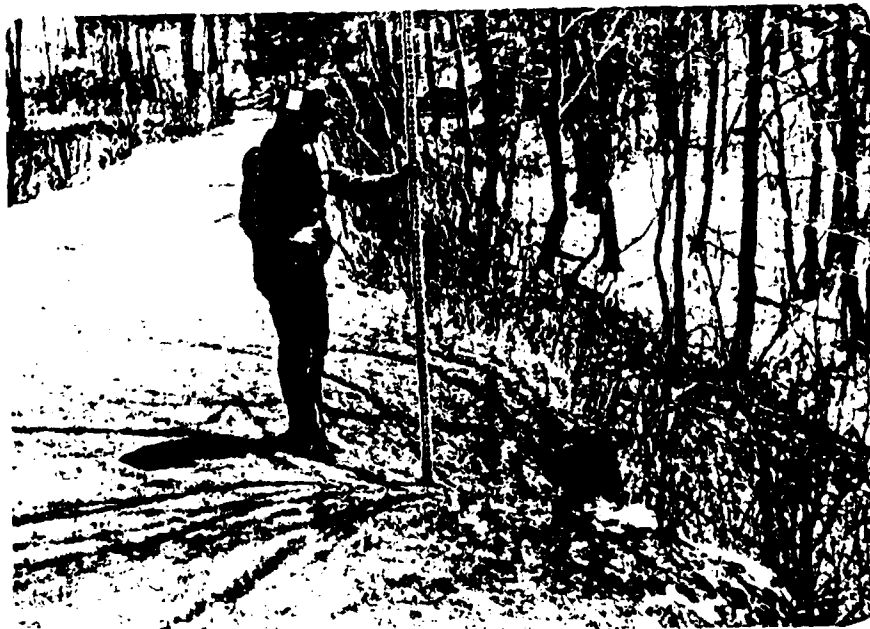
There is a minor surface runoff swale eroded into the downstream edge of the top near the outlet works (Photograph D). The downstream slope is covered with mature trees and brush growing through the stone cover (Photograph E). The downstream slope is uneven, with minor ripples in the stone covering the slope. About 25 feet to the left of the outlet works, the downstream toe is about 6 feet further downstream than at adjacent sections. This appeared to be an as-constructed condition. Tailwater at the dam is caused by Mountain Lake; the upstream end of Mountain Lake is at the toe of the dam (Photograph H). No seepage was observed at the dam.

D. Top of Dam and Downstream Slope

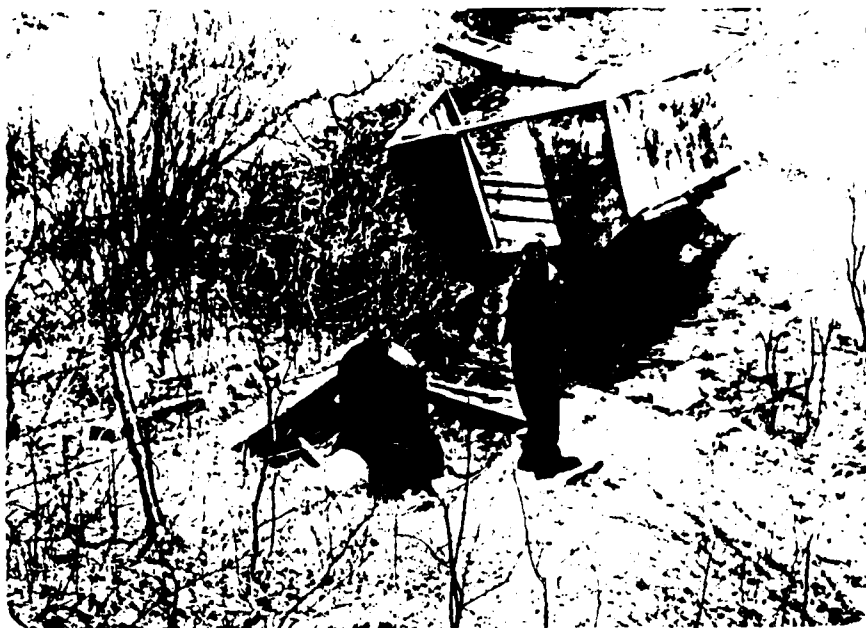
The outlet works is in poor condition. The timber frame gate house is capsized downstream of the gate valve (Photograph I). The gate valve itself has a 1.5-foot long crack through the gate housing. The nuts securing the gate housing are so rusted that only a small portion remains. The Owner's agent offered to operate the valve until he discovered that there was no operating mechanism. He did not recall the valve ever being operated.

(3) Appurtenant Structures. There is no evidence to suggest that the outlet works is operational. There are no upstream closure facilities for the outlet works. The severely-rusted, securing nuts and the cracked gate housing could cause the valve to jam, if it were to be operated. If the outlet works is not operational, there would be no means to draw down the lake in case of an emergency. It is surmised that the timber frame gate house overturned during a strong wind; no means of securing it to the concrete foundation was observed. Even in place, it probably provided only marginal protection against the elements.

I. Outlet Works

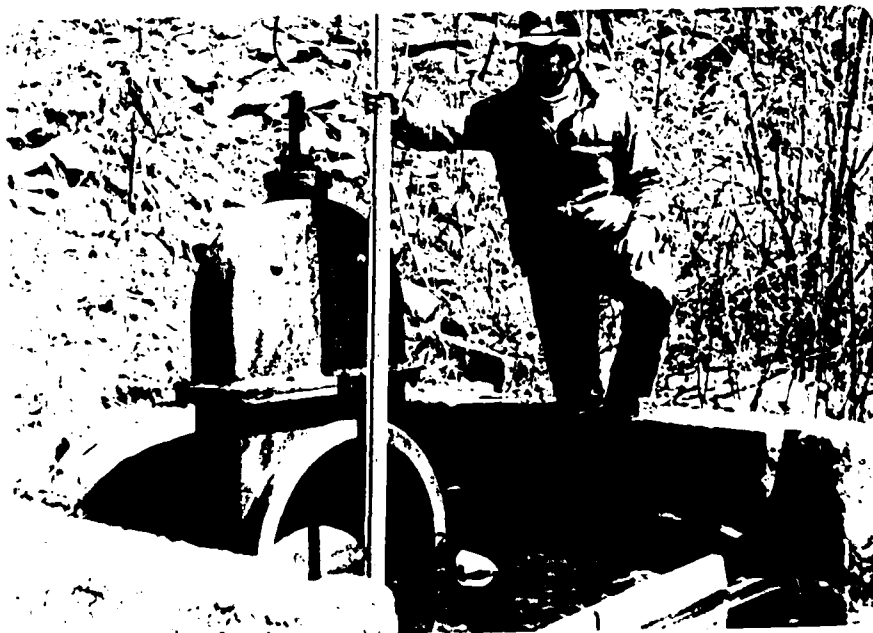
II. Outlet Works Valve
